MIDLANDS BOSUNS DAY 16/10/21

This year saw the very first Midlands Bosun's day, a day designed to teach club bosuns how to make simple repairs on boats via several methods, therefore preventing unnecessary expenditure of professional repairs. Funded by a BUSA development grant and hosted by Sam Penhaul Smith, a professional boat repairer, the day covered the removal of self-bailers, different methods of boat repairs, alongside ropework and fixing improvements. Relevant PPE was also provided to all participants. The day also allowed the midlands bosuns to network with each other, which will enable them to discuss repairs in the future. It was such a success that another session with further techniques has been requested by those who attended.

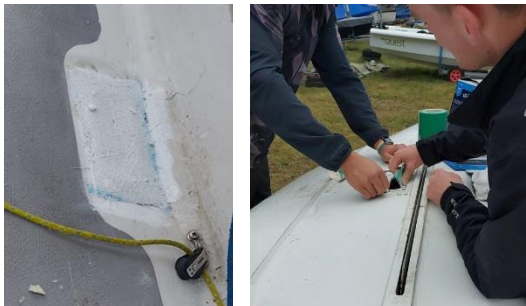
REMOVAL OF LEAKING SELF BAILERS

Leaking self-bailers is a common issue on university fireflies, however often clubs do not have the knowledge or confidence to remove the bailers themselves. The removal of these was also useful in demonstrating the process of a simple hull repair. 3 boats were used for the demonstration, allowing bosuns to do the work themselves in groups of 2 or 3, learning the correct techniques for removal of the bailers, preparation of the hole, and fibre glassing to fill the hole. Two different repair processes were used to further the knowledge gained.

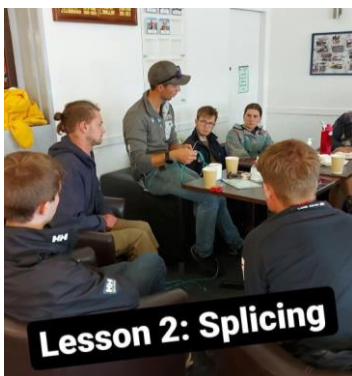
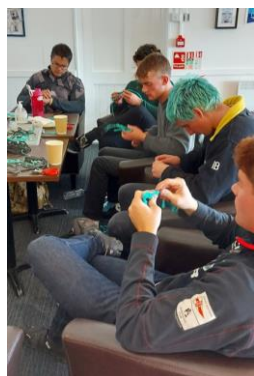
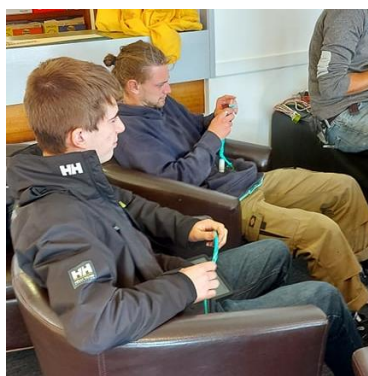
SPLICING

With bailer repairs setting, the day moved onto a lesson in splicing and ropework, including how to make a rope shackle. After a short demonstration on each process, each Bosun was given a piece of rope to practise with for the remainder of the session.

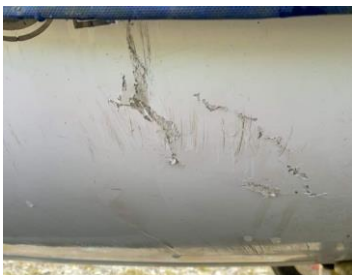
FIXING A LARGE REPAIR

A further demonstration on the repair of a large hole was also given. The boat used had blown off a trolley and therefore had a large area in need of repair. The first image displays the damage before the repair occurred. The demonstration included how to prime the hole for repair, alongside how to complete the fibreglass work. Unfortunately, due to time constraints the fibreglass was not set enough to finish the larger repair, and therefore the sanding at the end of the repair was not completed. The rest of the process was discussed with the group before the end of the day.

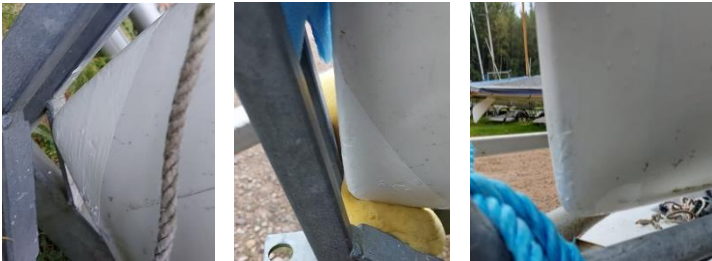
GELCOAT REPAIRS

The final topic covered involved the simple gelcoat repairs of holes within the hulls of the boats, particularly focusing on those holes at the bow as seen in the images. With 3 boats to choose from the bosuns were again all given the chance to complete the repairs and try out the techniques in practise.
